Third Five-Year Review Report
for
Raymark Industries, Inc. Site
Stratford, Connecticut

September 2010

The United States Environmental Protection Agency
Region 1, New England
Boston, Massachusetts

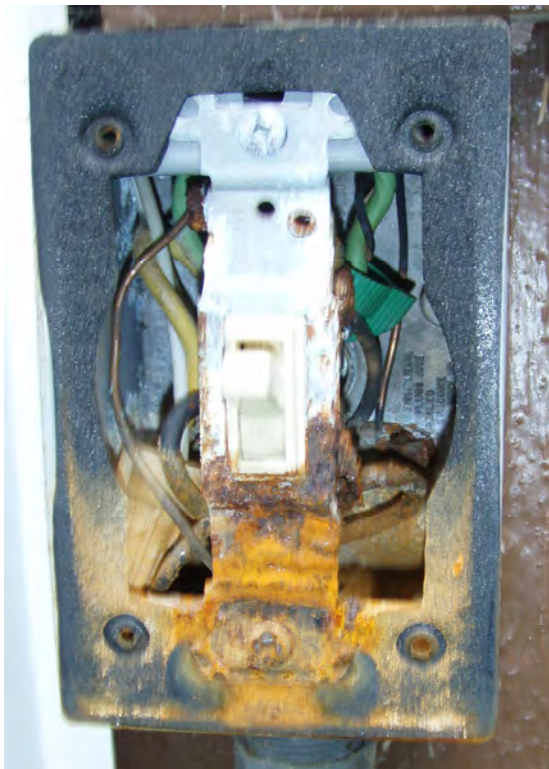
Photograph 13) House #46 – 405 Housatonic Avenue: Electric Box

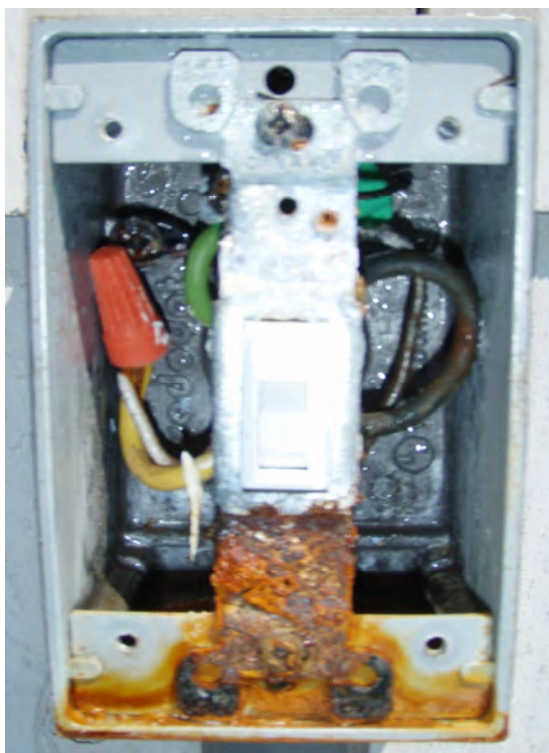
Photograph 14) House #55 – 492 Housatonic Avenue: Electric Box

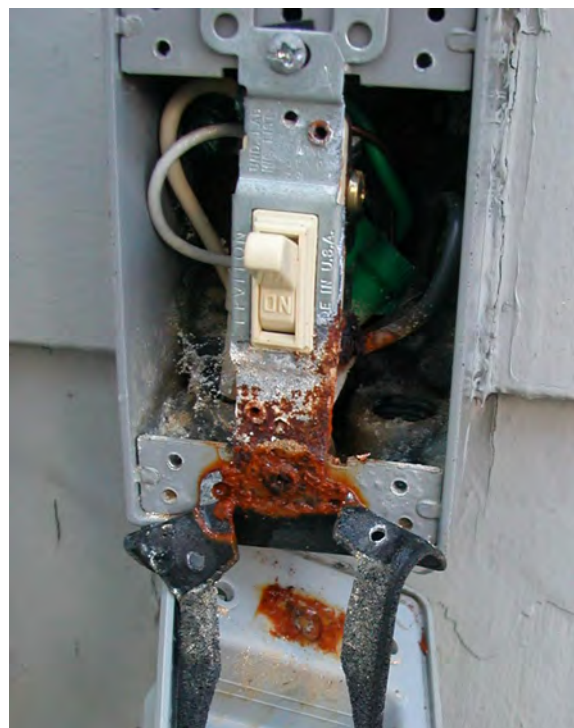
Photograph 16) House #67 – 56 Minor Avenue: Electric Box

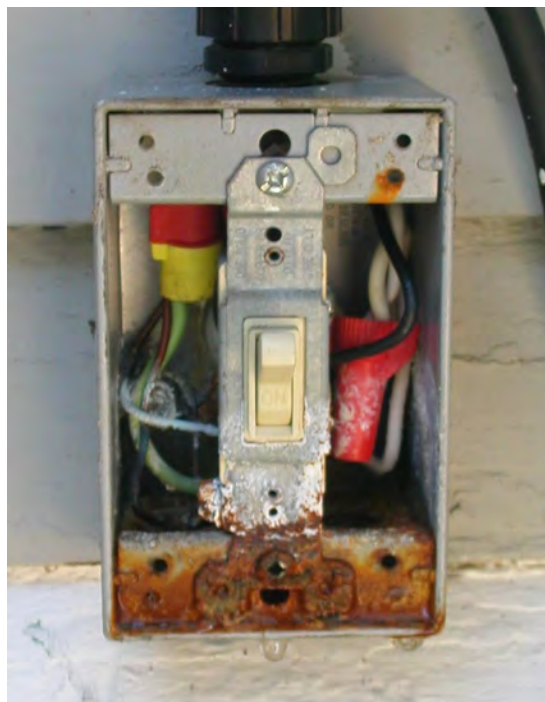
Photograph 18) House #70 – 83 Minor Avenue: Electric Box

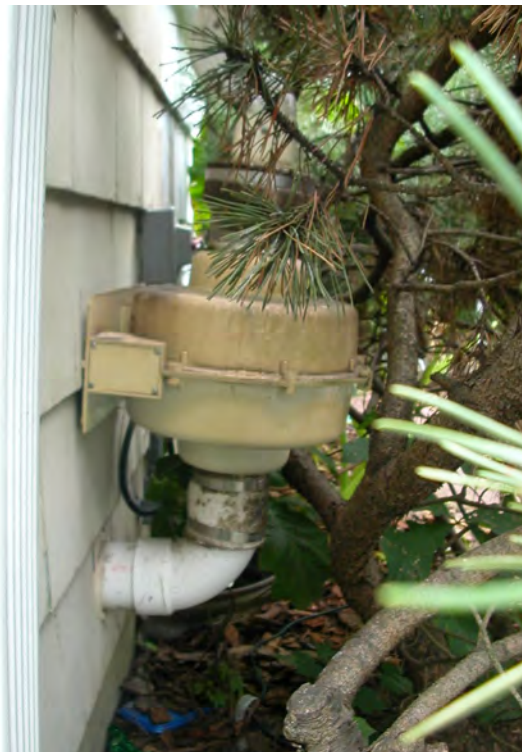
Photograph 25) House #101 – 120 Willow Avenue: Large Bush Preventing Access to Electric Box

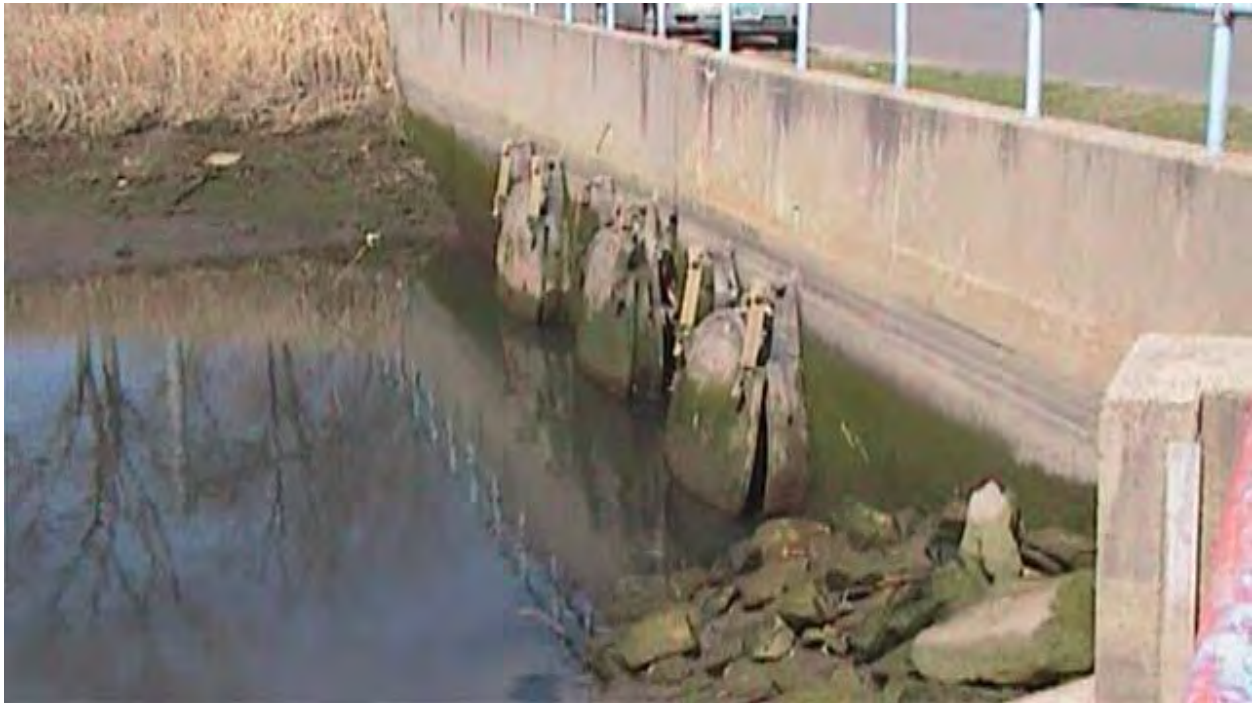
Ferry Creek flood gate.

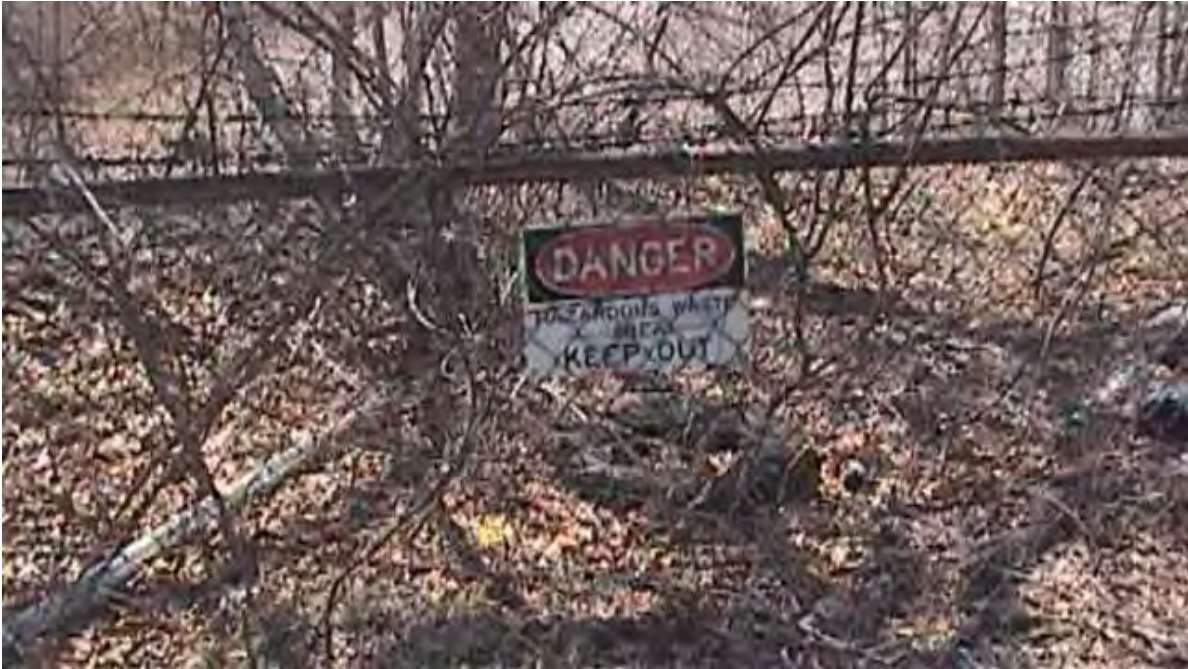
Warning Sign on fence between Contract Plating and OU4 (faces toward Ballfield to warn about Contract Plating).

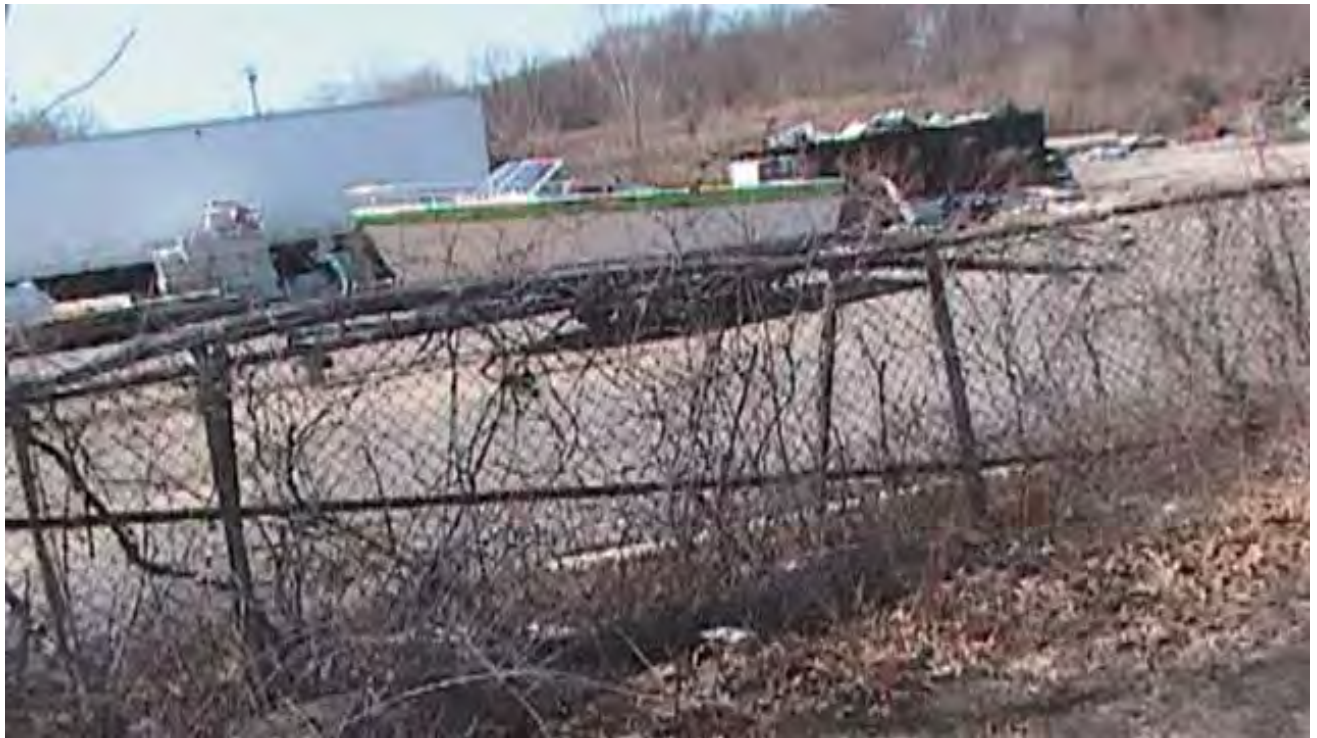
Storage pad off Frog Pond Lane.

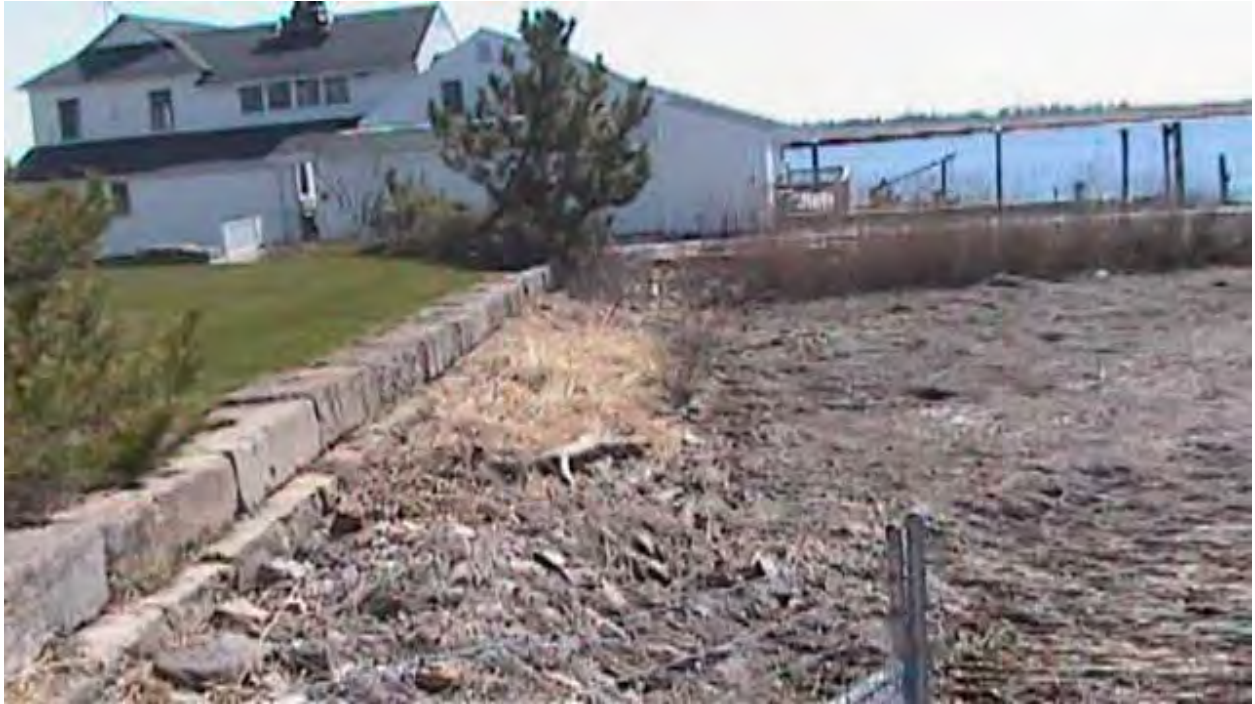
Retaining wall.

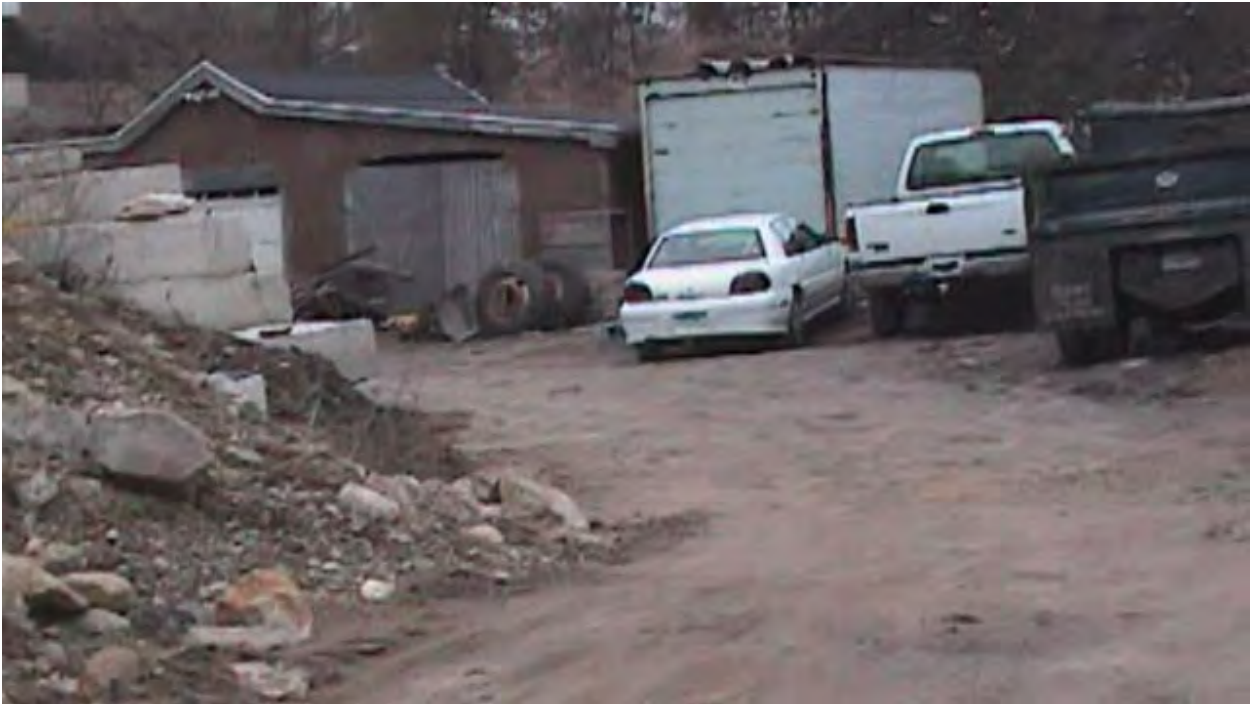
Inside fence near front of property.

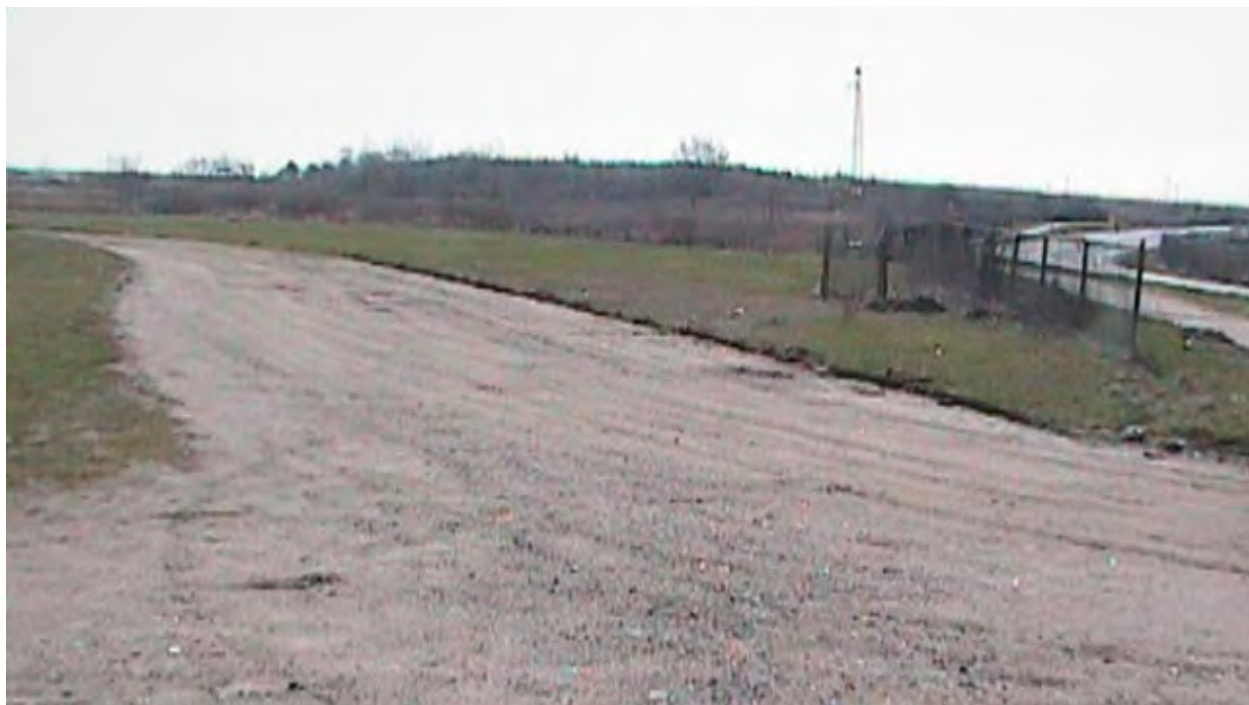
View from the entrance of Raymark waste disposal area.

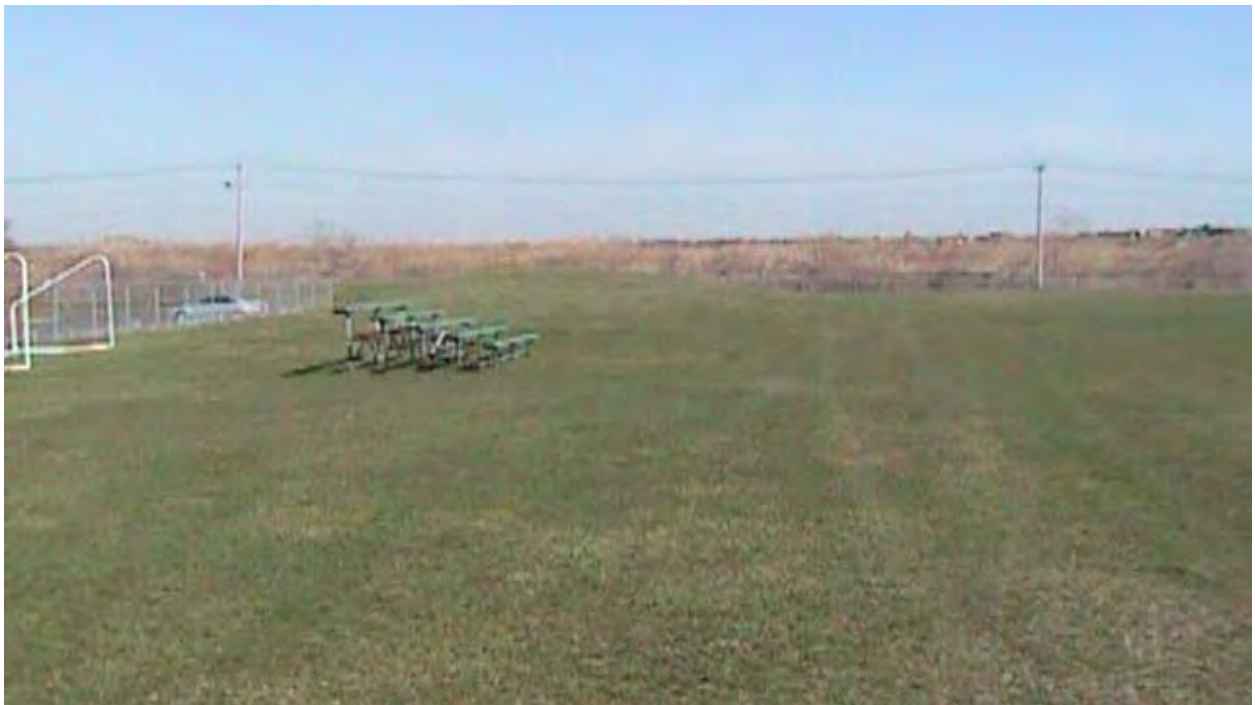
Short Beach Park looking across the golf chipping area toward baseball fields (area of Raymark Waste).

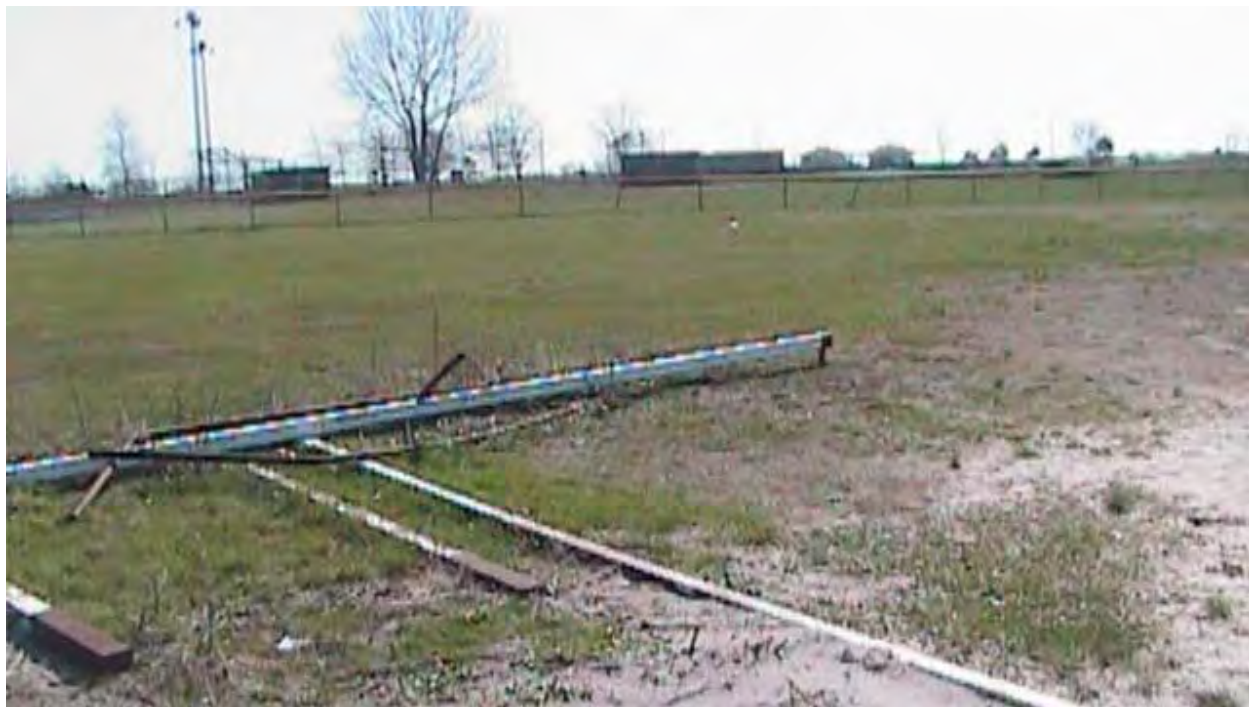
Landfill along Dorne Drive.

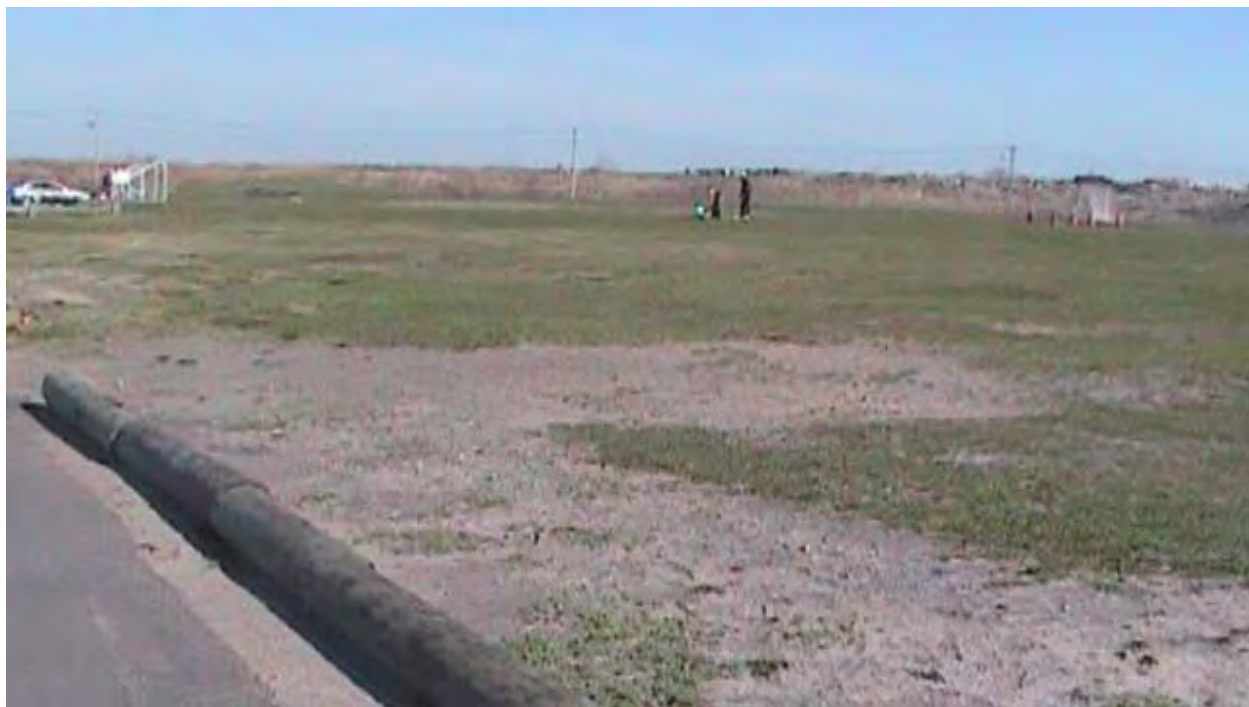
Landfill.
